**MARITIME
ARCHAEOLOGICAL
ASSOCIATION
REPORTS**

Volume 2 : July - December 1988

Notes on projects of the Maritime Archaeological Association of Western Australia.

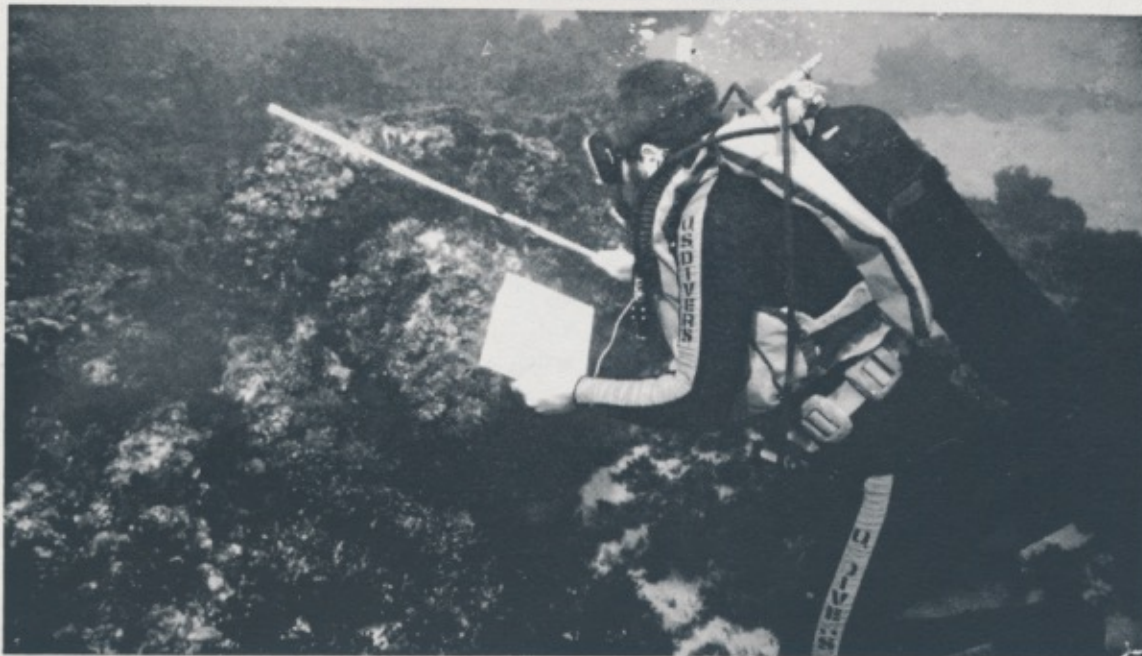
Colin Cockram using a measuring rod to produce an isometric drawing of one of the winches on the Lady Elizabeth - Photograph by Brad Sargeant.

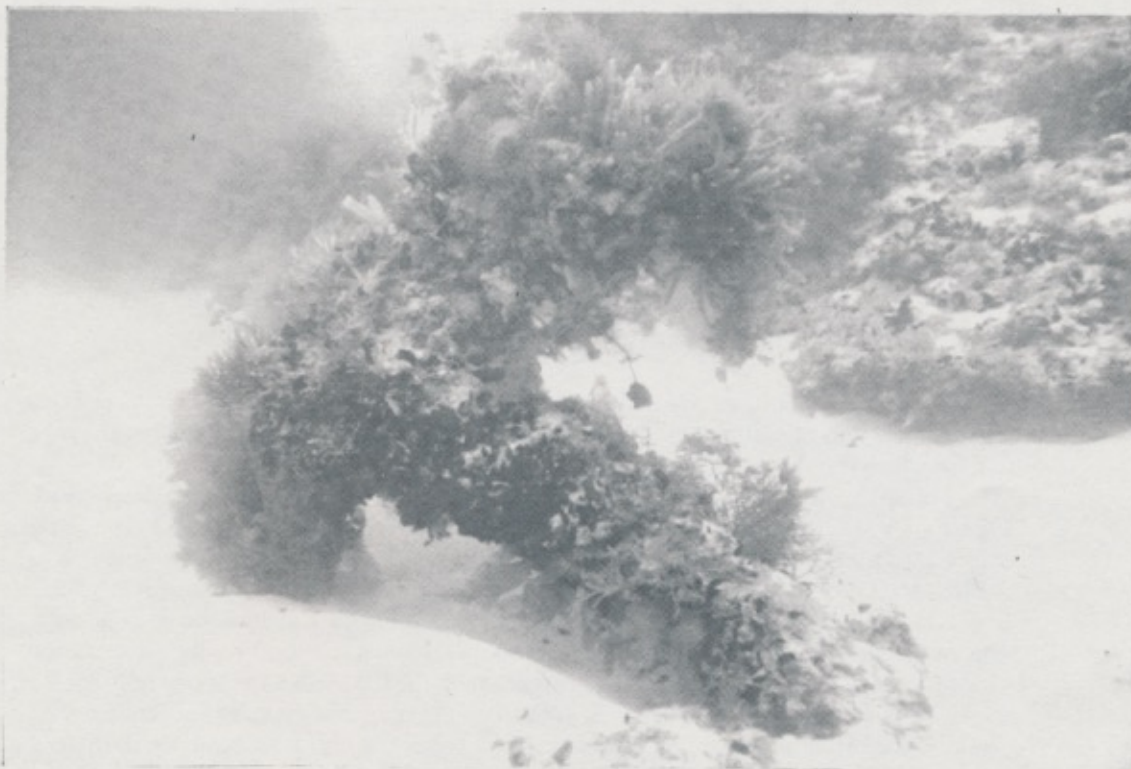
During the initial search we also examined the area of Collie Ledge, on the southern side of the channel across from Collie Head, where a group of anchors were reported in 1981 by Graham Anderton. We found one anchor (see picture) which was close to a large protruding rock, and we are inclined to agree with the view that this originally held a marker bouy. While this does not relate directly to the Cambria, there was some discussion at the Inquiry about the reliability of the marker bouys, and this may indicate that the Cambria was in line with, or very near the bouys when it sank.

The anchor found by MAAWA divers on Collie Ledge

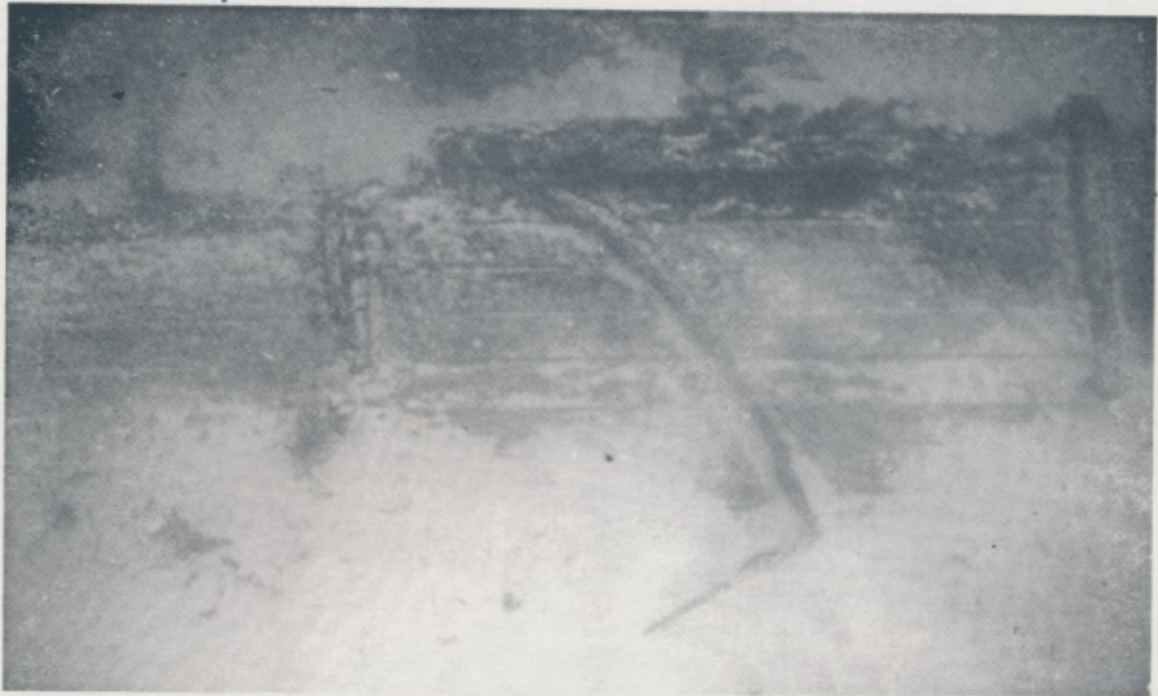
The iron knee which is clearly evident among the timbers of the Zedora site -

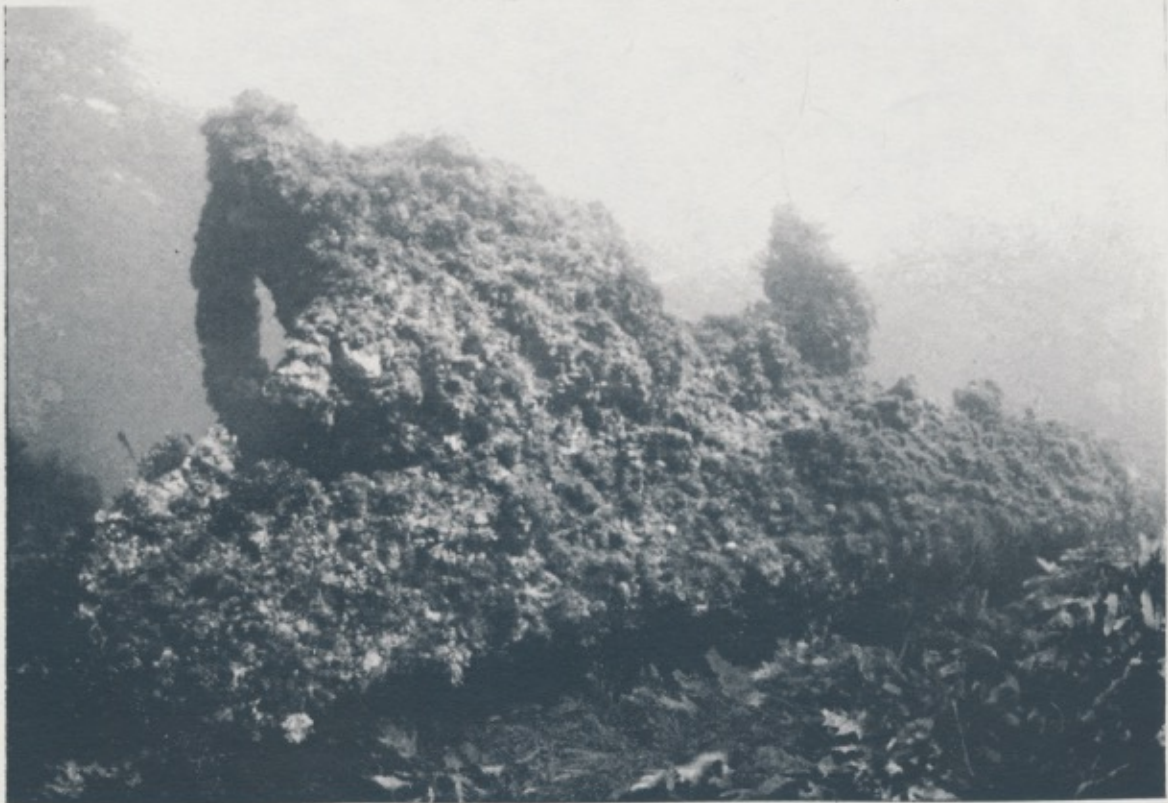
Part of the wreckage of the James Service - Photograph by Dave Totty

Much iron plating has fallen both into the internal area of the ship and surrounding areas. This plating presents a confusing picture until one is able to swim over the whole site to ascertain main structural features.

The plating may cover artefacts. Comparison with the slides taking in 1985 indicates that much plating has either fallen or corroded away from the frames. The wreck may still be continuing to disintegrate, hence the need for detailed mapping of the site to plot the development of this process.

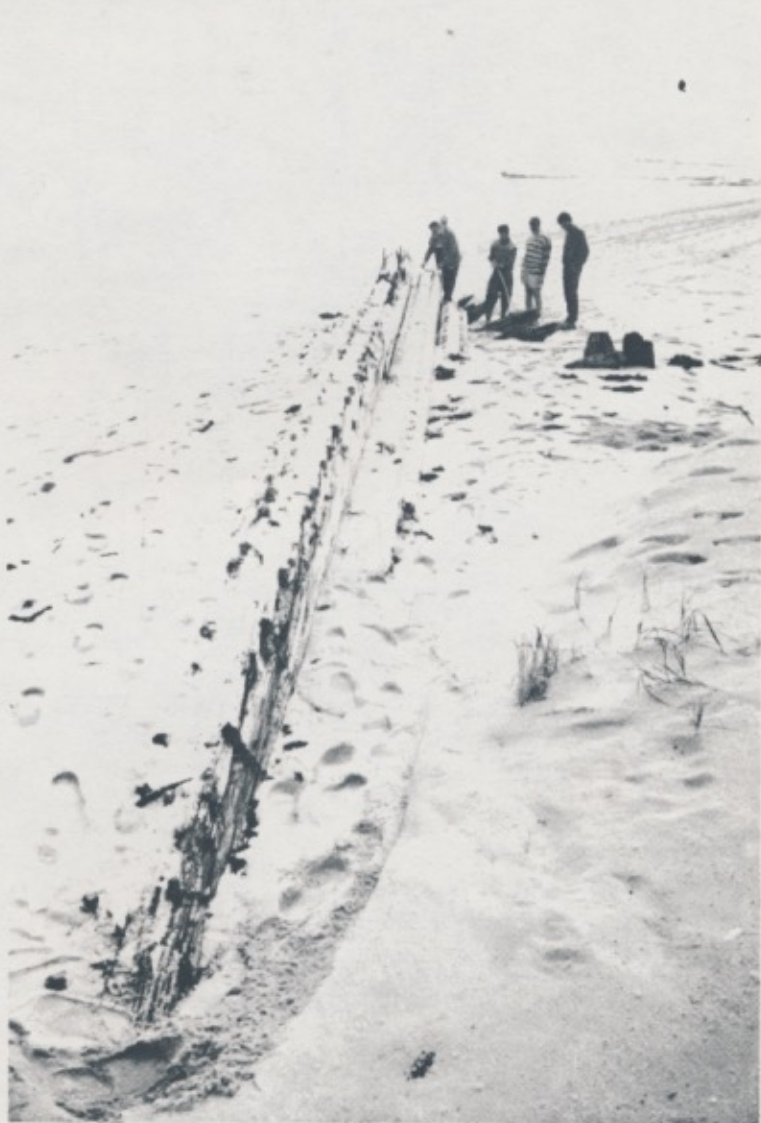
The keel of the Alex T. Brown lies at an angle to the surf on the beach at Yanchep - Photograph by Brad Sergeant.

Timbers forming the keel and keelson remain evident, buried in the sand in two sections at angles to each other, indicating that the vessel at some stage broke into two. From the main section, lying at an angle to the waterline of about 45 deg. the remains of several frame timbers are visible, each containing several trenails.

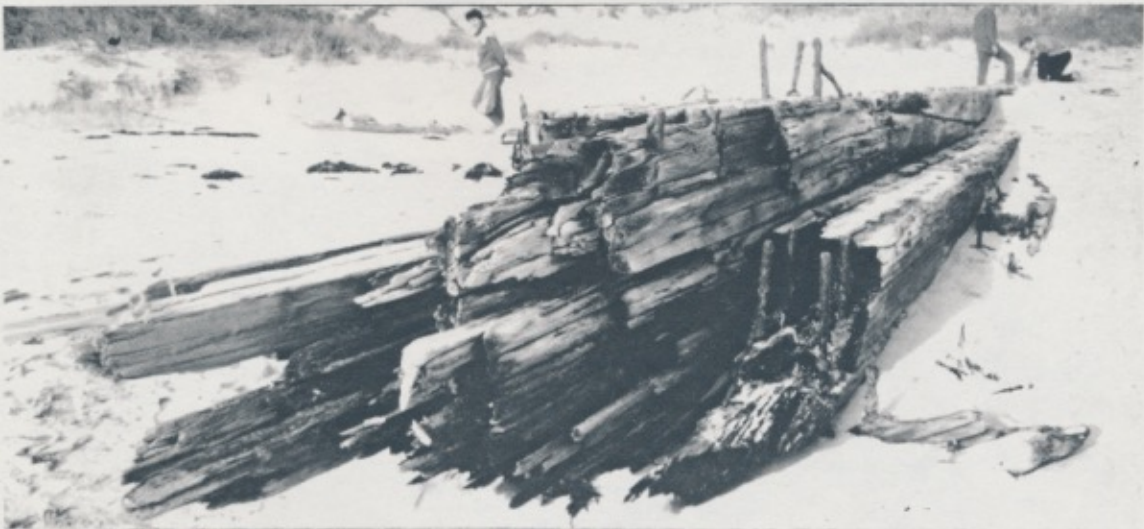
*The sea end of the keel timbers - damaged by fire at some time in the past -
Photograph by Brad Sergeant*

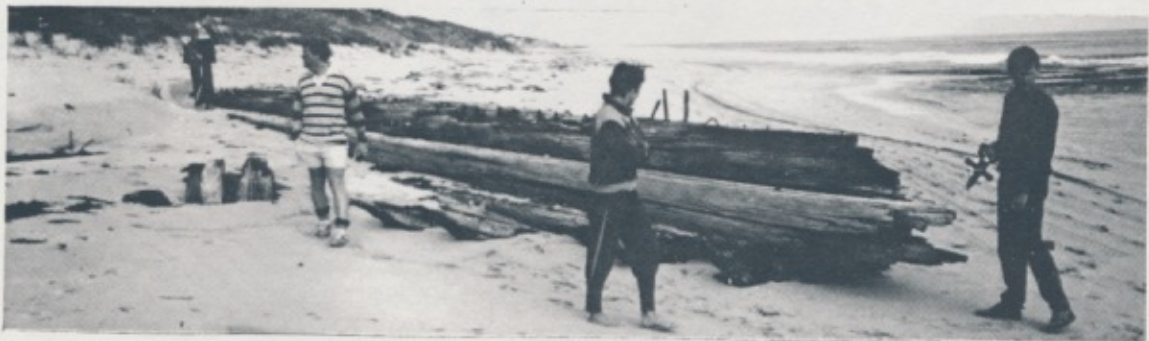
MAAWA members measuring the remaining timbers of the Alex T. Brown
